UNITED STATES DEPARTMENT OF AGRICULTURE

FOREST SERVICE

HEBGEN LAKE •• MADISON RIVER EARTHQUAKE DISASTER

AUGUST 1959

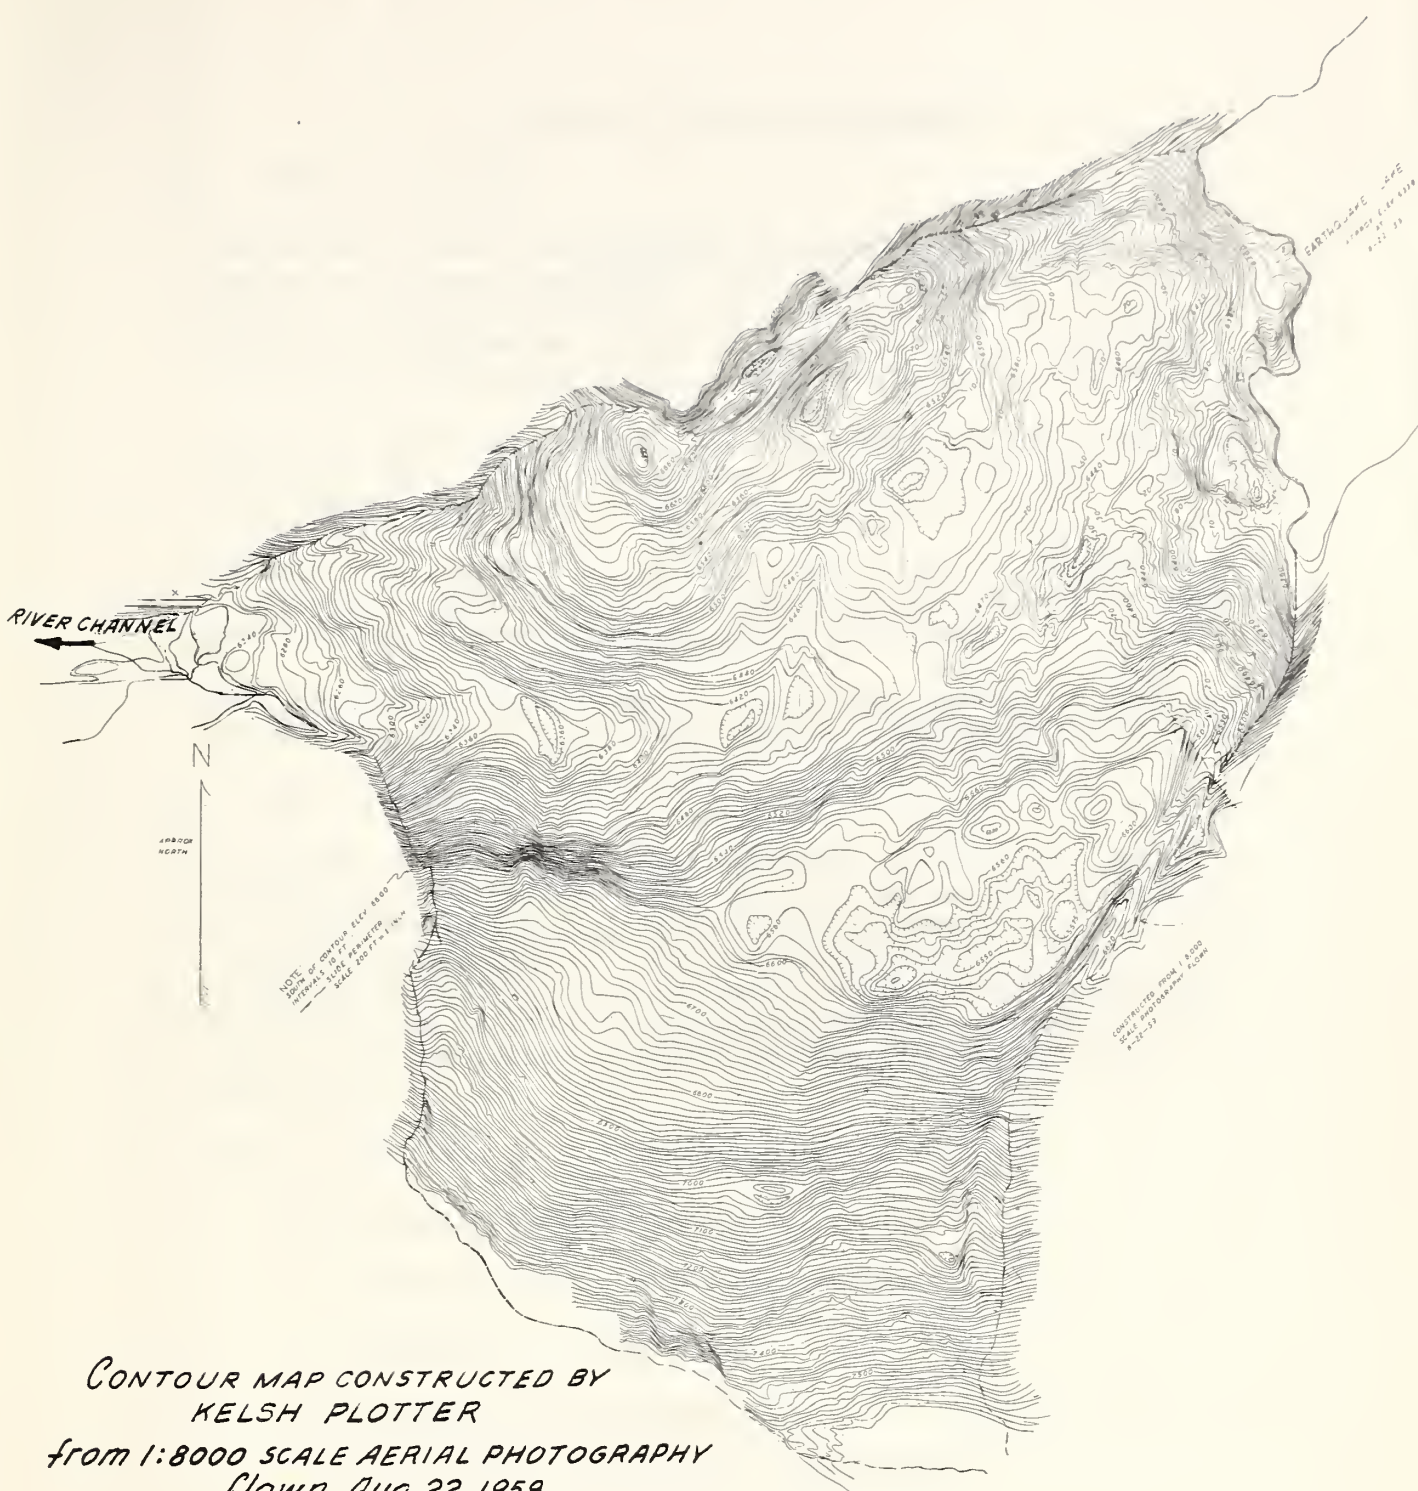
EARTHQUAKE SLIDE MADISON RIVER-1959

CONTOUR MAP CONSTRUCTED BY
KELSH PLOTTER
from 1:8000 SCALE AERIAL PHOTOGRAPHY
flown Aug. 22, 1959
by U.S. FOREST SERVICE

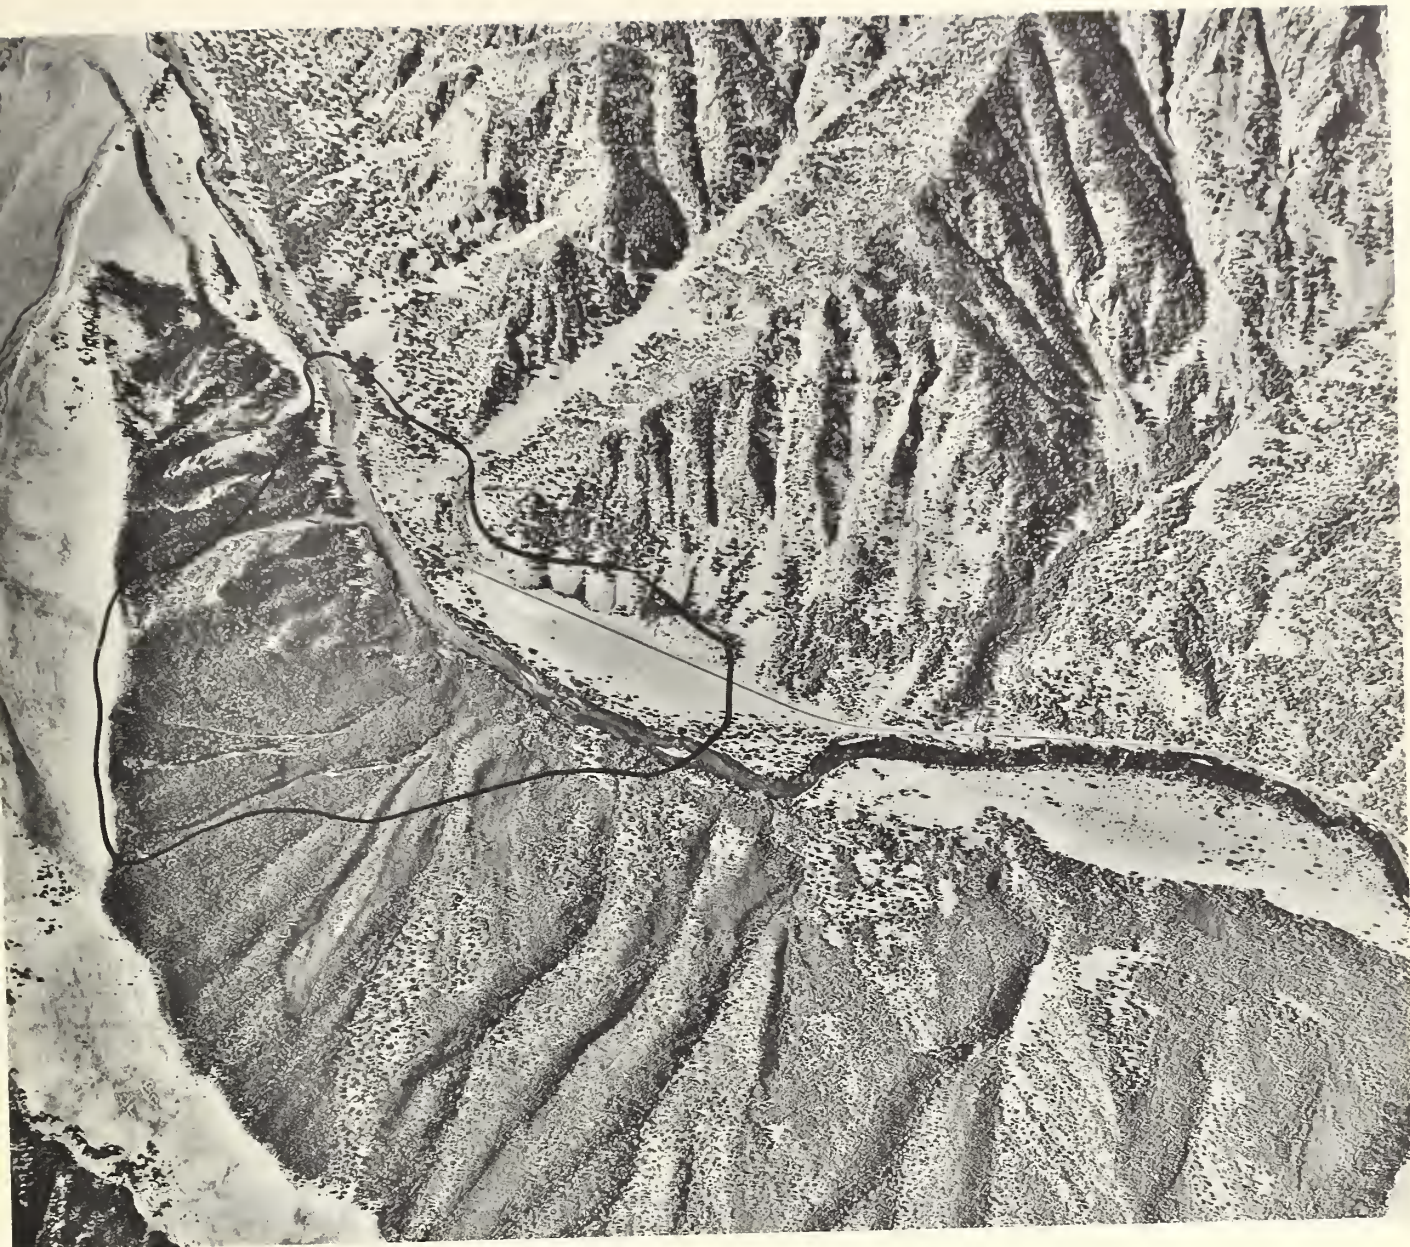
Madison Canyon before slide.

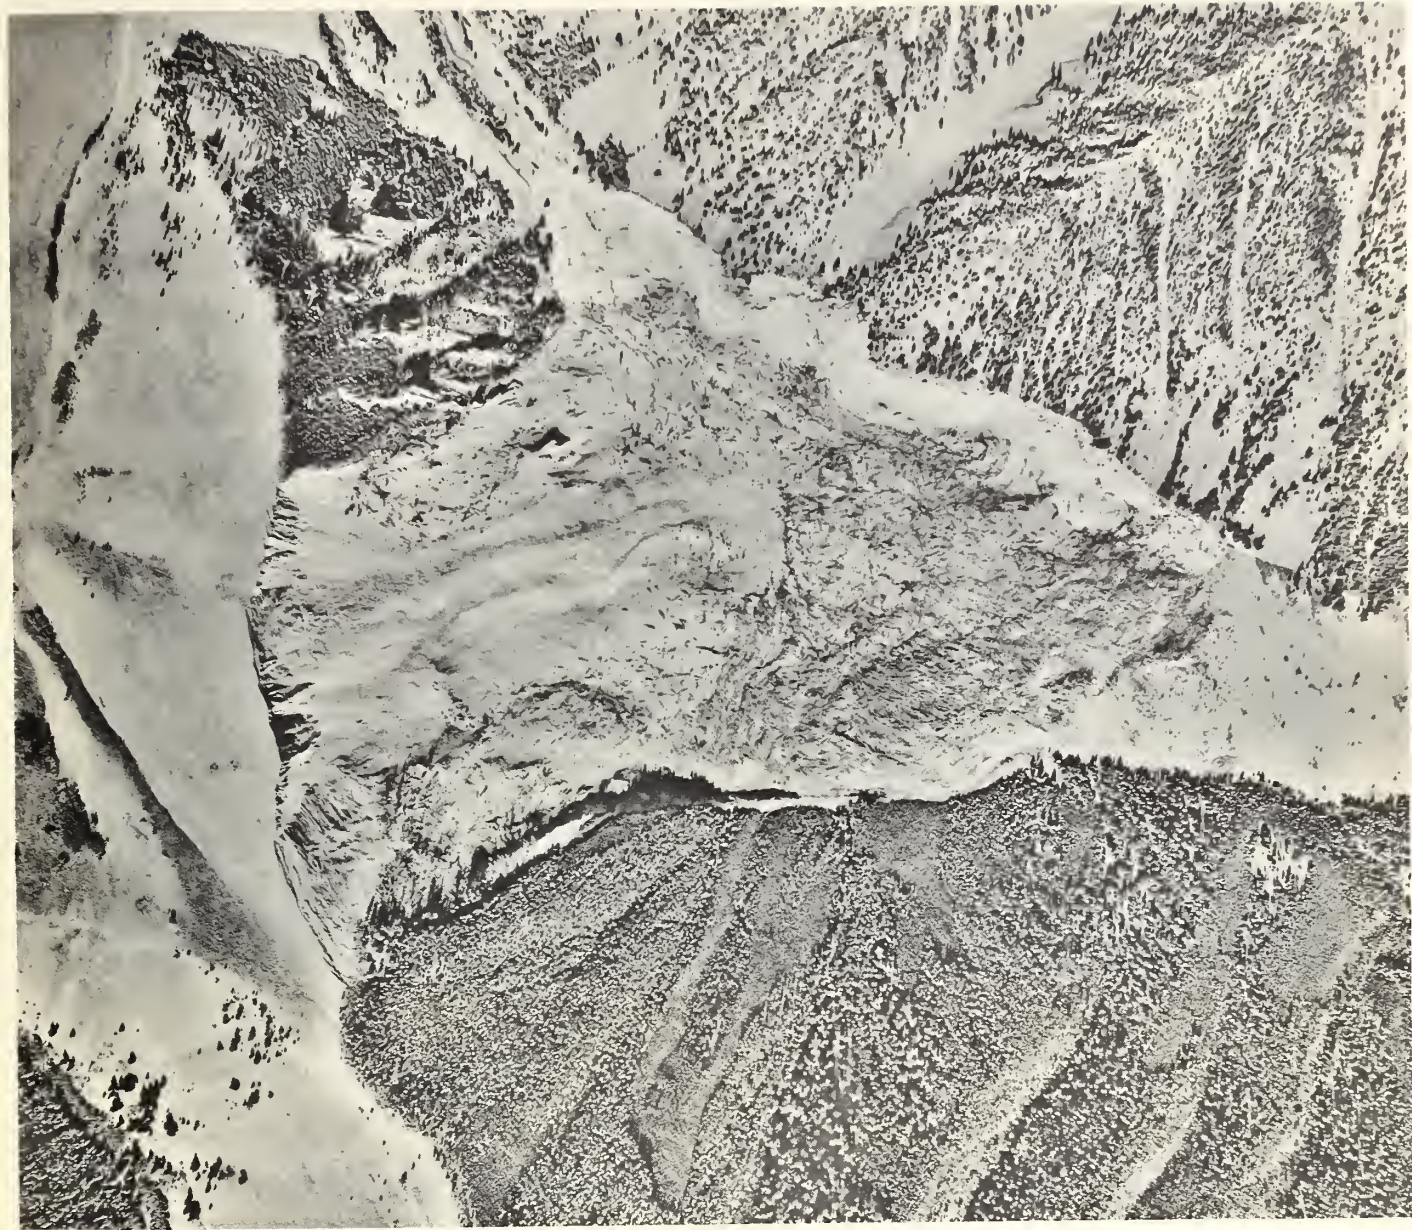
Madison Canyon after slide.

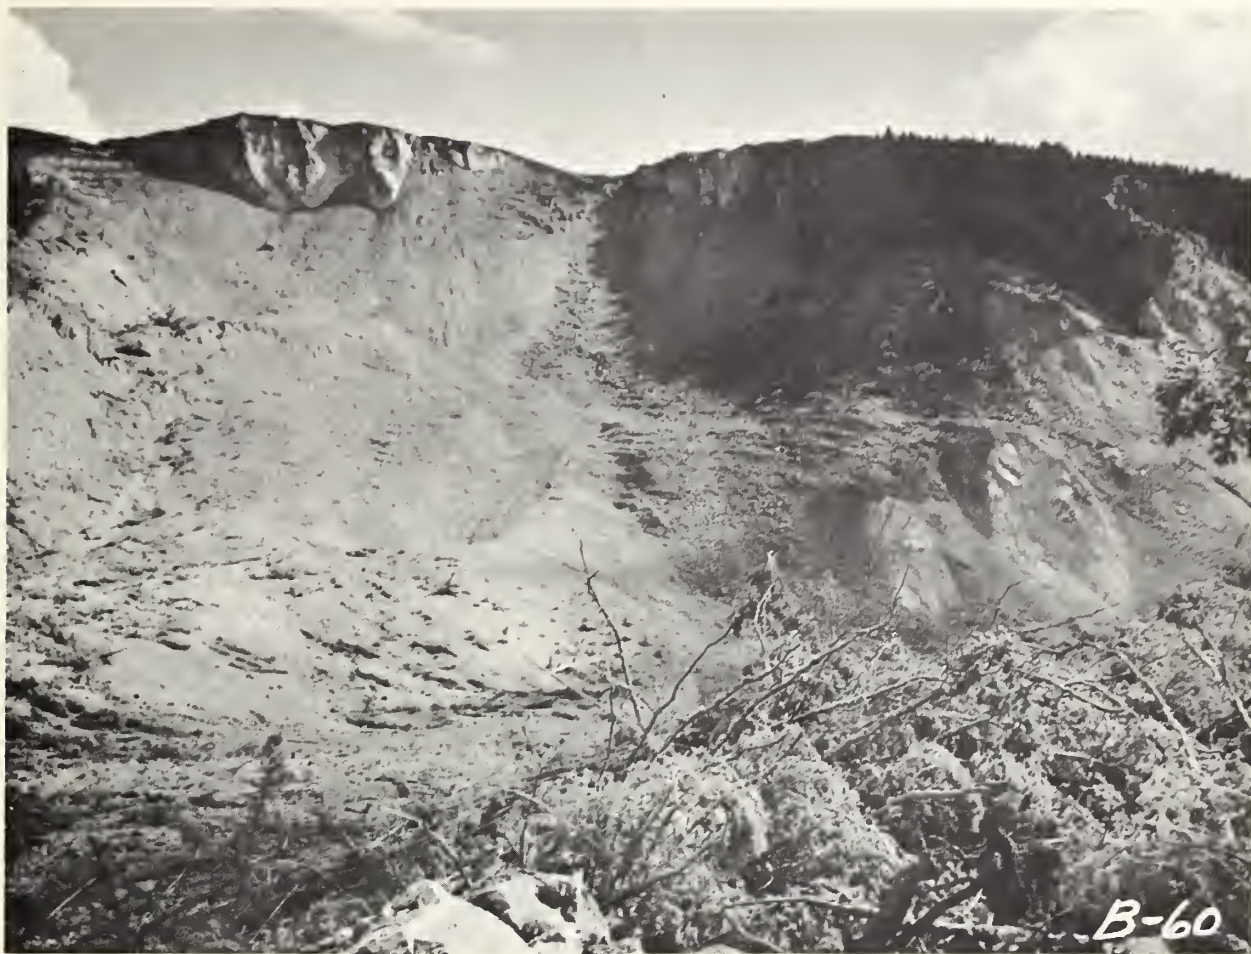
Slide Origin

West side of Madison River - view from high point of
slide debris.

The severe shock of the earthquake shattered this buttress which rendered it incapable of supporting the material above it. When the slide broke loose it pushed this dolomite or quartzite formation ahead of it and up the opposite side of the mountain to a height of almost 400 feet above the river bottom.

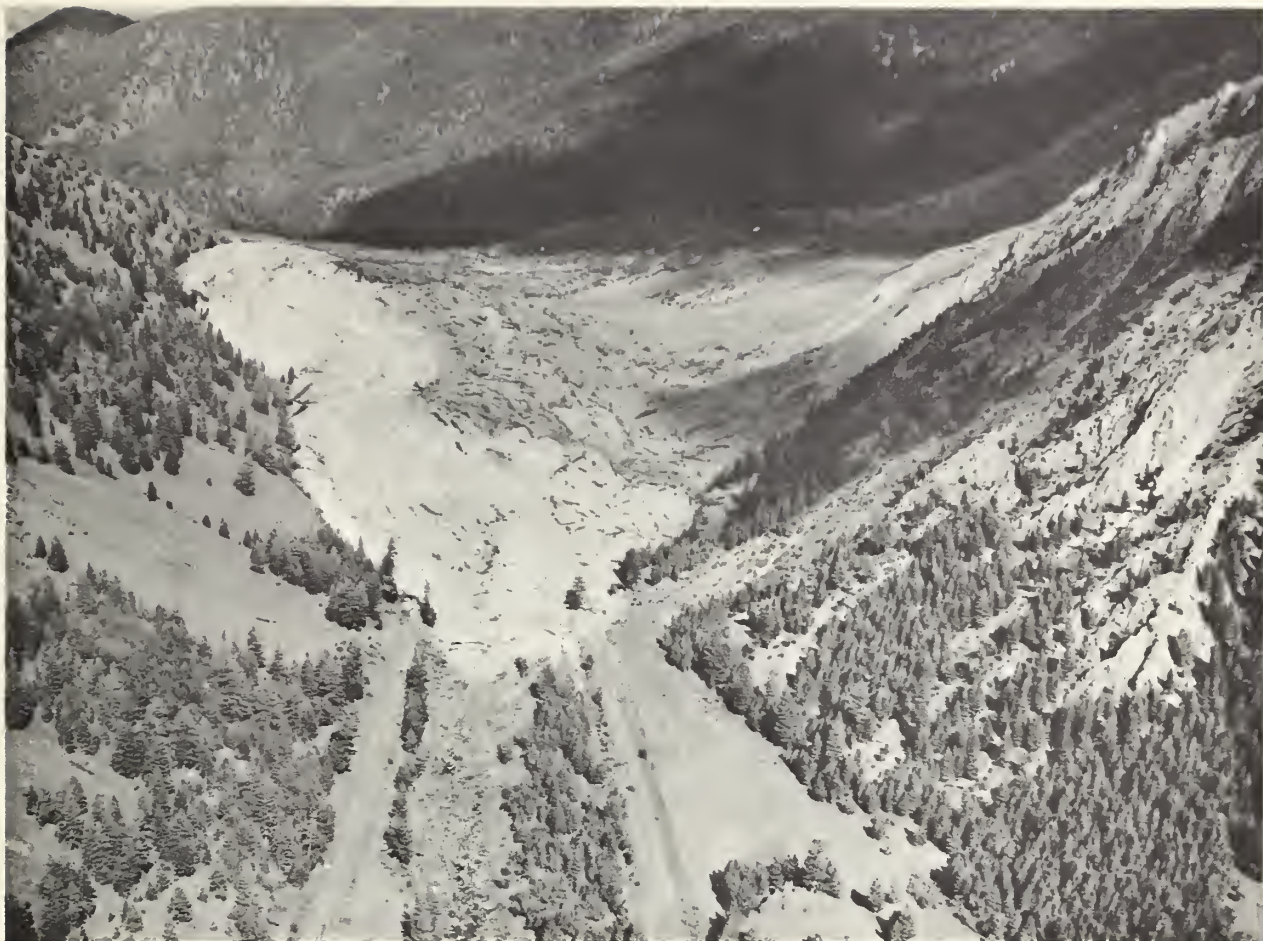
Massive Rock Slide

Downstream face of rock slide. State Highway 1 and
dry Madison River channel in foreground.

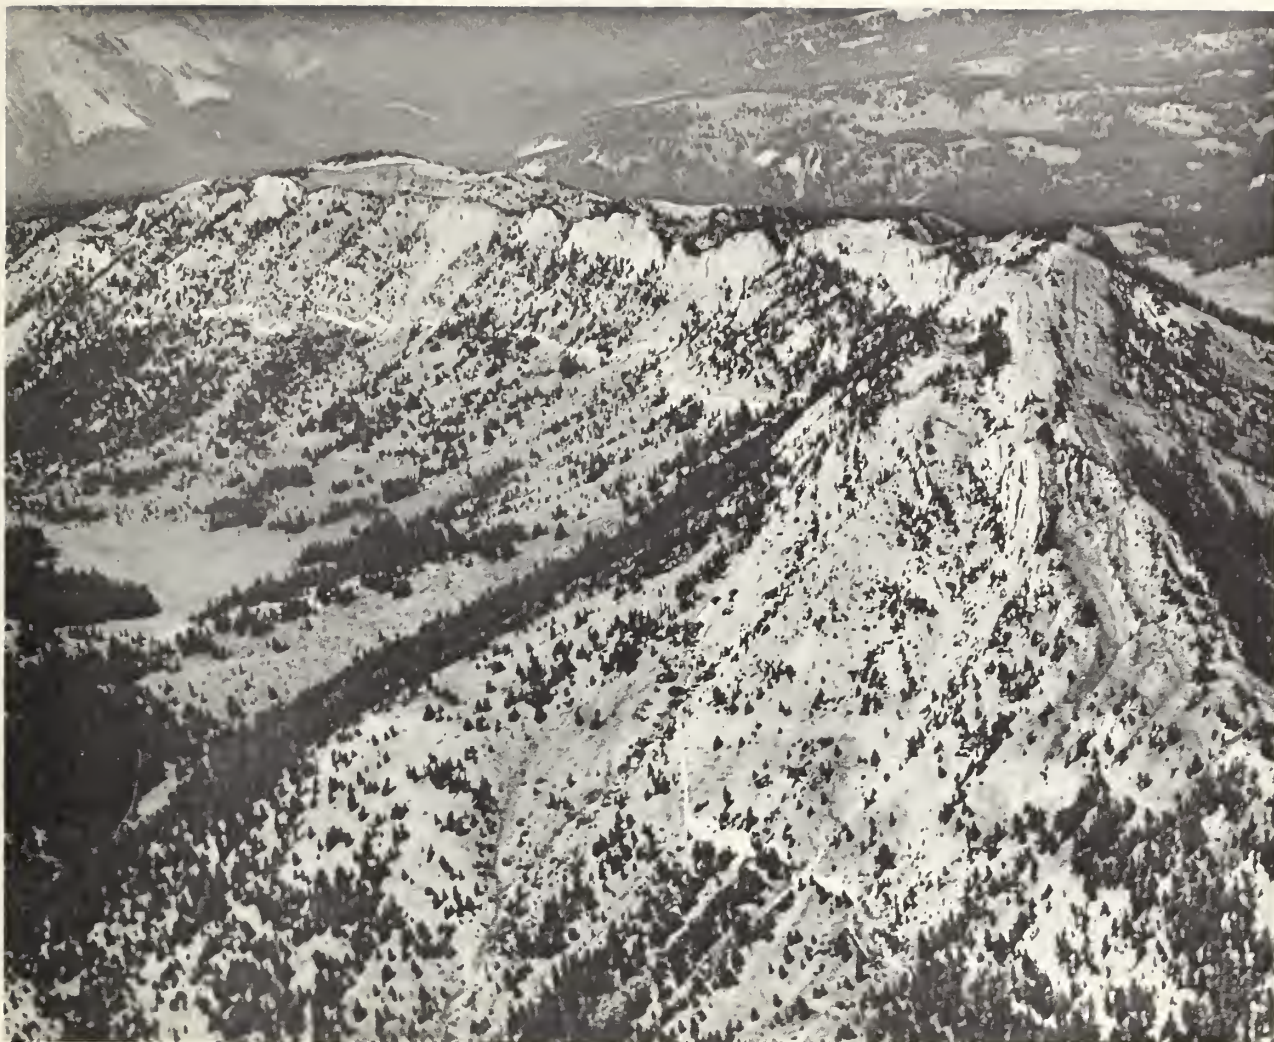
Fault Along South Slope of Kirkwood Ridge

This roughly parallels the north shore of Hebgen Lake.

The severe shock which took place at approximately 11:35 p.m., August 17, 1959, caused a sharply defined fracture in the earth's surface extending northwesterly from a point near the Yellowstone National Park boundary and passing just south of the junction of Highways U. S. 191 and Montana State Highway 287. It continues up the ridge east of Red Canyon Creek and thence northwesterly near the top of Kirkwood Ridge to Boat Mountain, approximately 2 miles north of the Hebgen Dam. Geologists consider this the line of an old fault. The fracture caused by the new quake showed a vertical displacement of 10 to 20 feet.

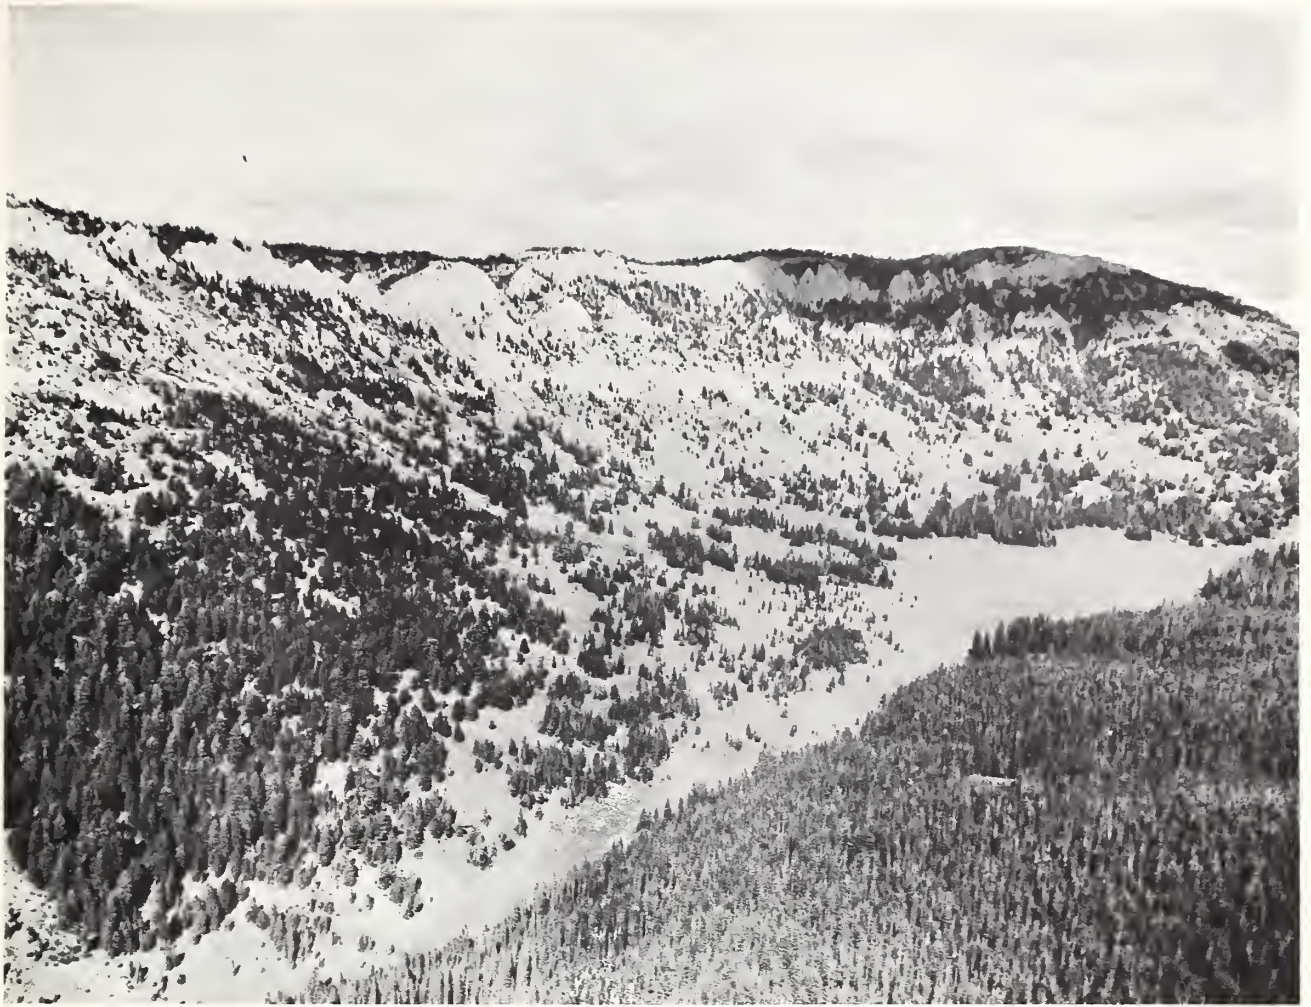
Fault line near top of Kirkwood Ridge east of Hebgen Lake. Vertical displacement along this fault is as great as 21 feet.

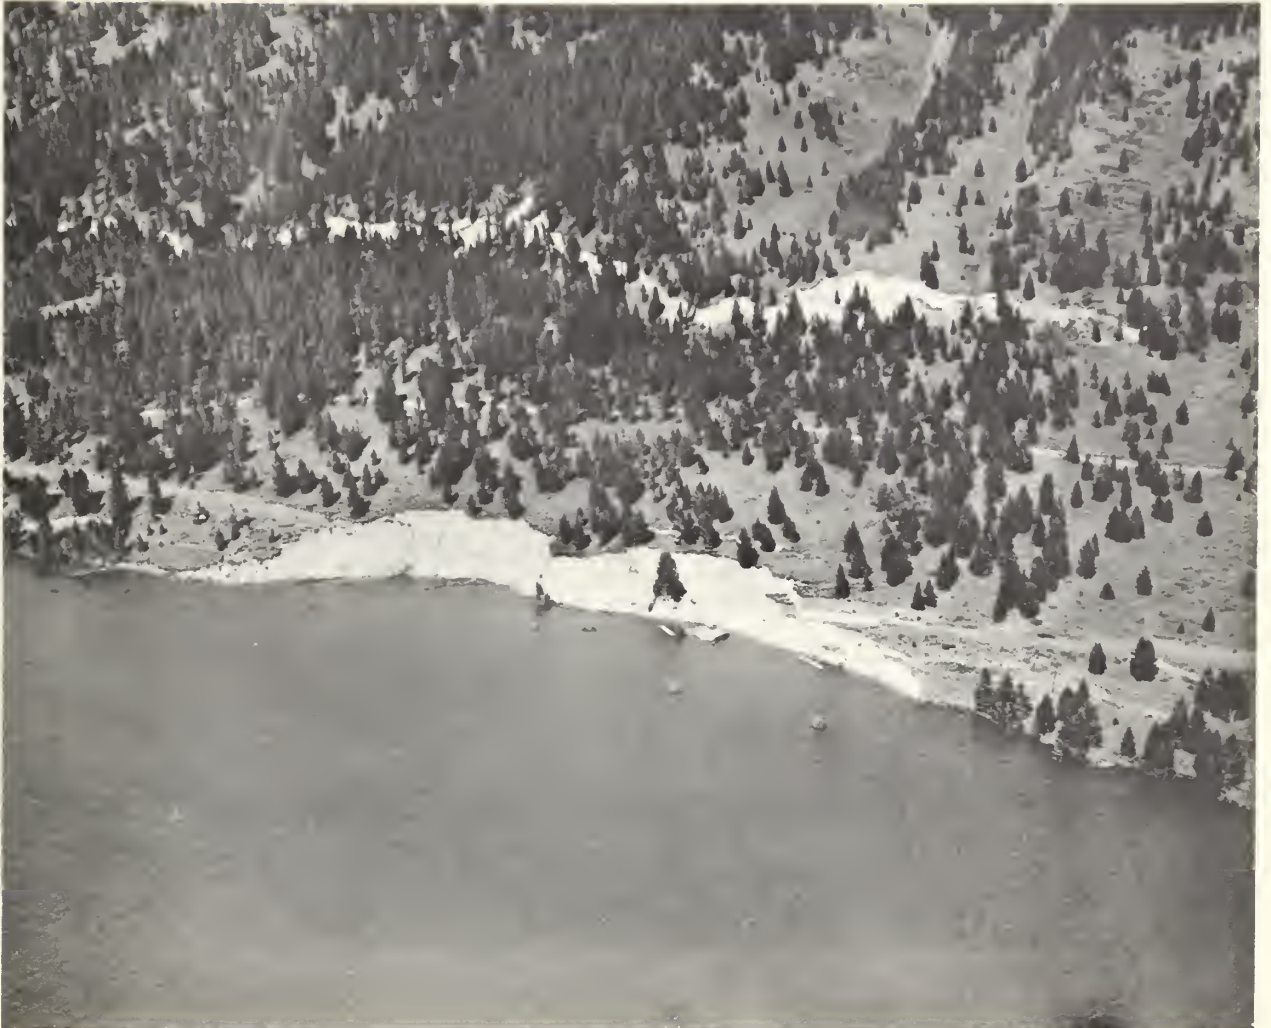
Hebgen Fault

A portion of the Hebgen fault north of Hebgen Lake. Notice where State Highway and building slipped into lake. Road between fault and slip out was built to evacuate trapped people.

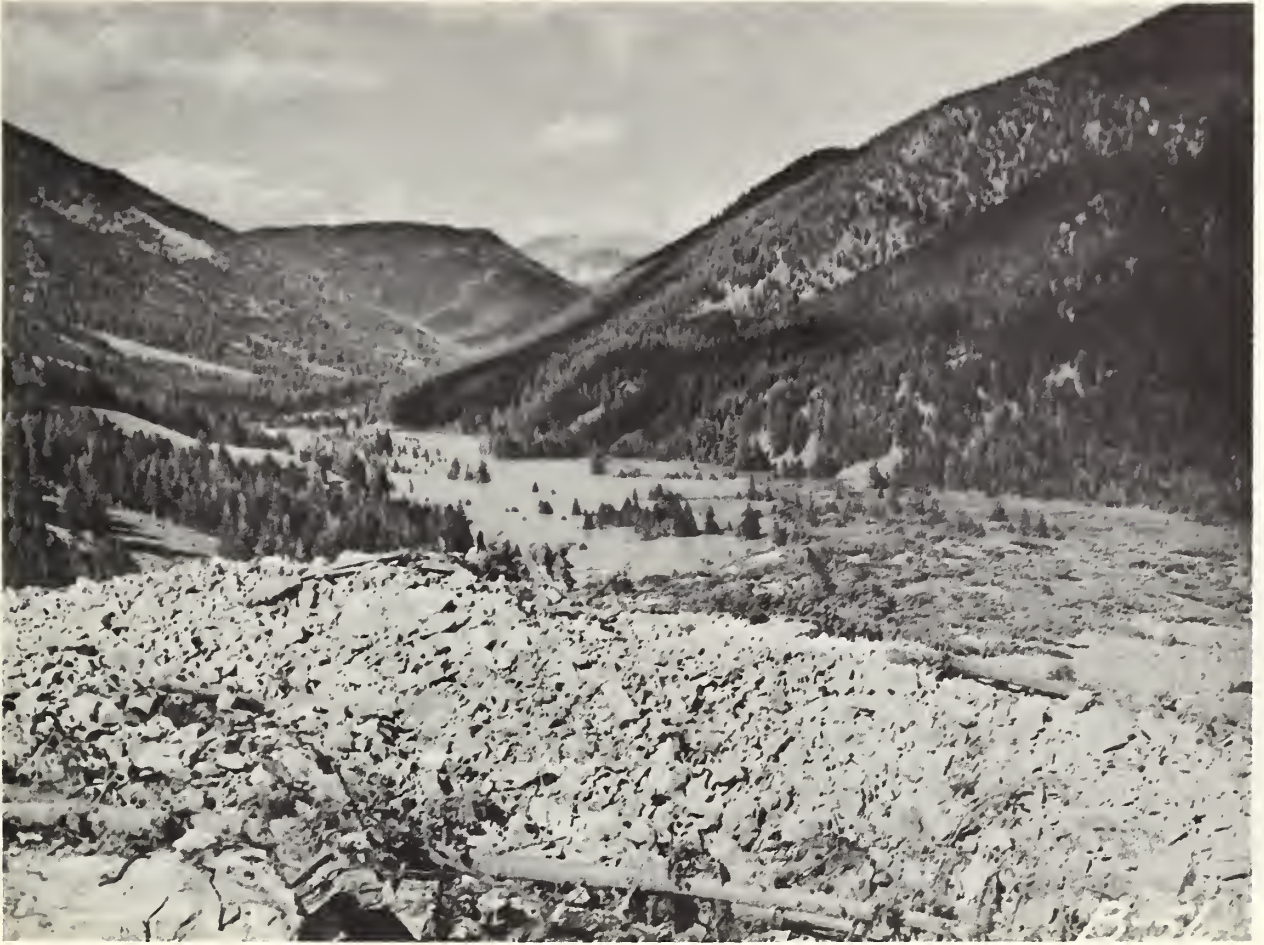
Earthquake Lake

Lower end of lake at upstream edge of slide. Lake beginning to fill. Flooded tree area in center of picture is Rock Creek Campground.

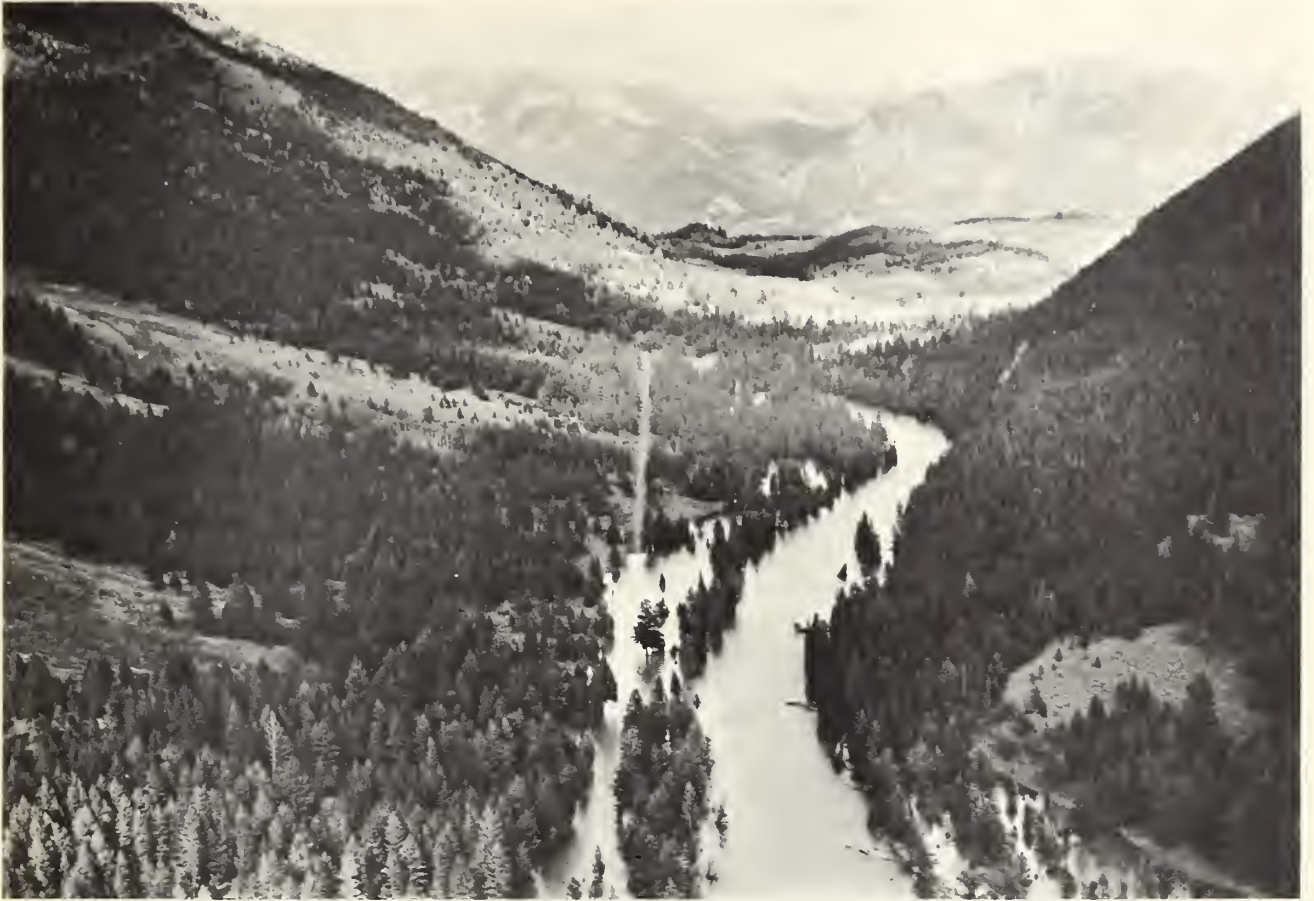
Earthquake Lake

Upstream view on August 21, 1959, of lake gradually filling and flooding highway, campgrounds, and resorts.

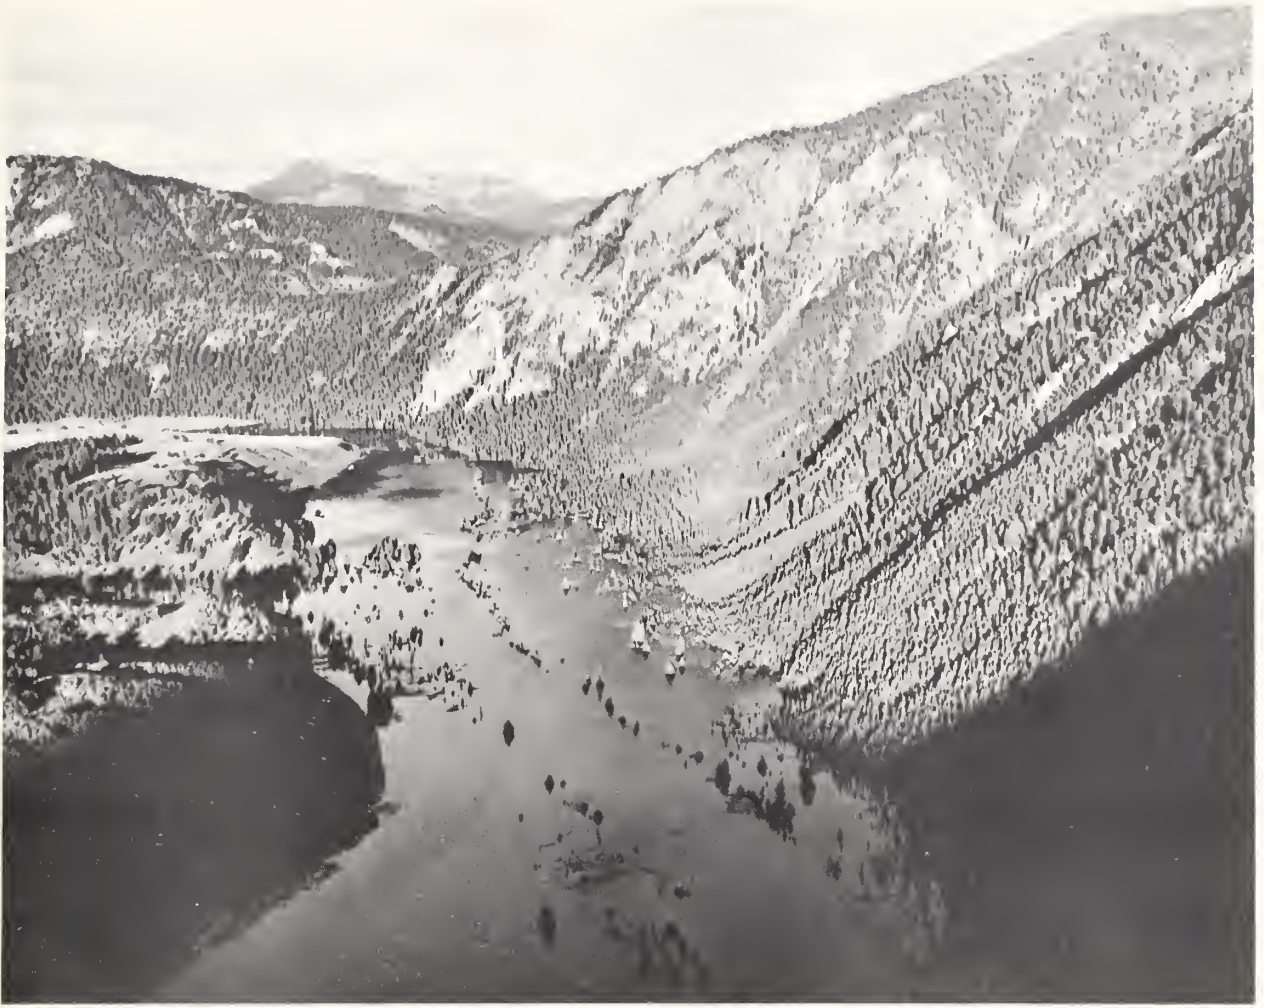
Earthquake Lake being formed behind slide in Madison Canyon. Note submerged trees lining old river channel.

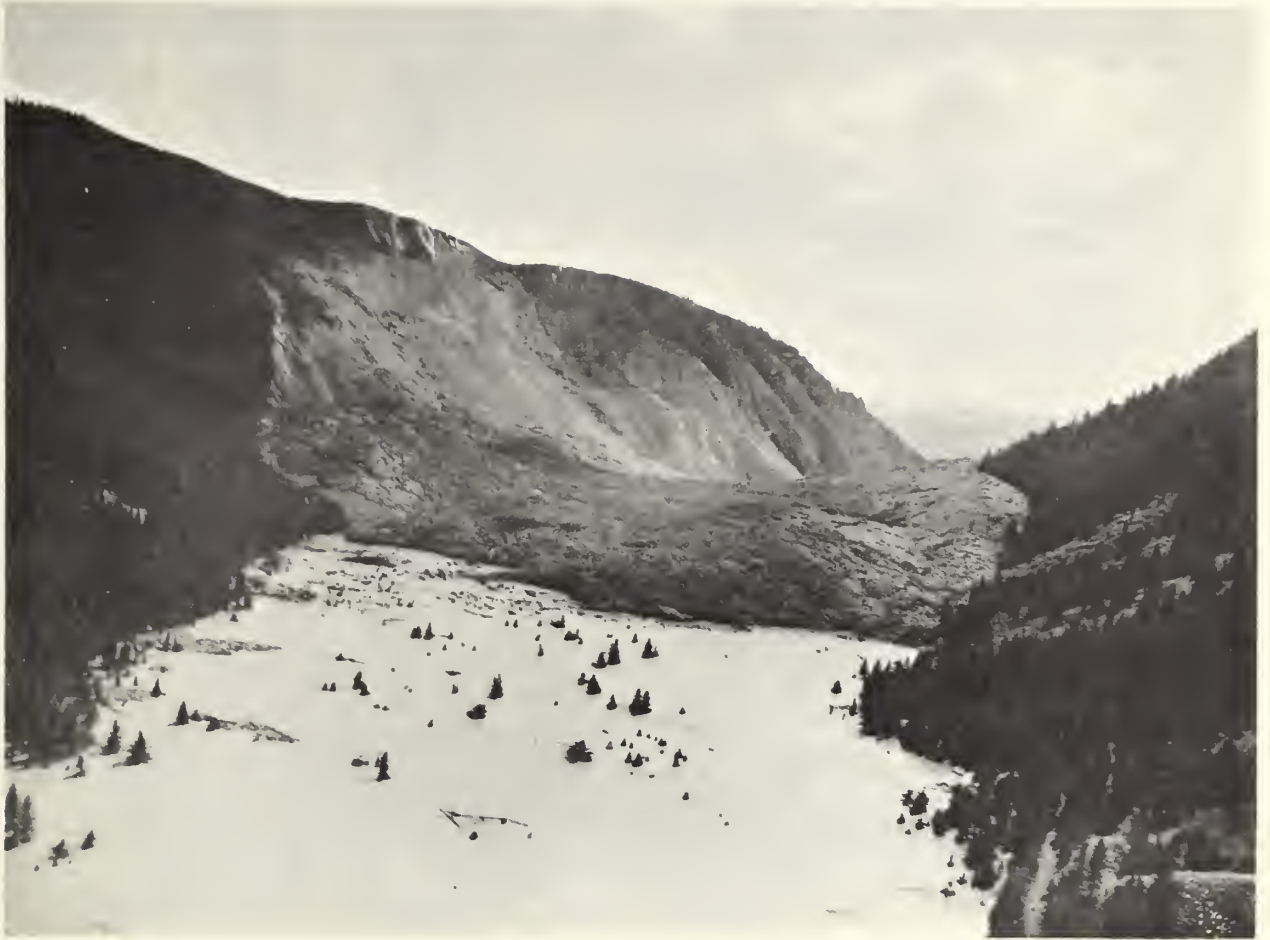
Earthquake Lake

Lake at upper face of slide. Flooded trees in center of picture indicate location of Rock Creek Campground.

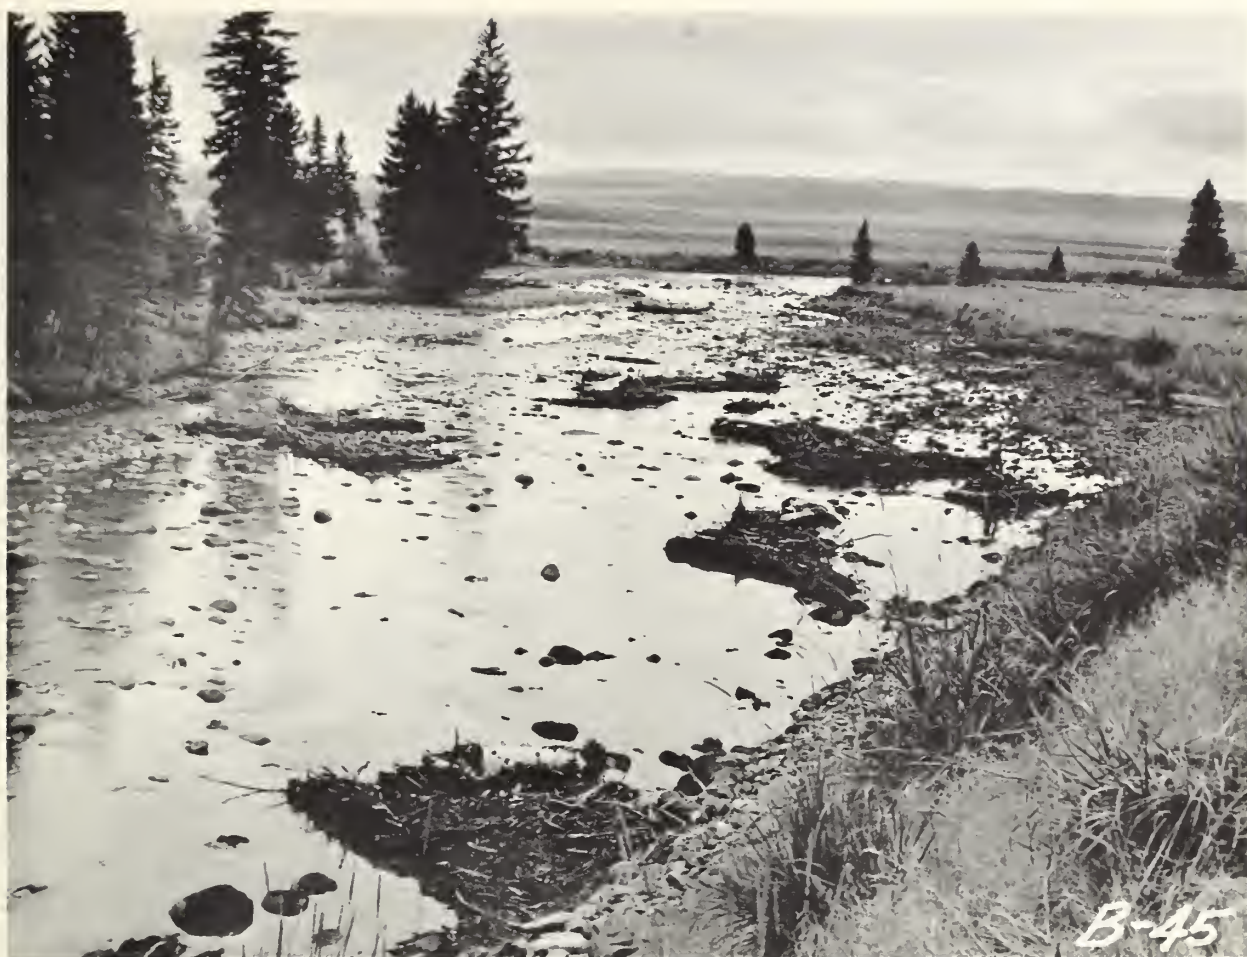
Madison River Below Slide

River almost dry below slide. Note high water marks and debris left by tidal wave from Hebgen Lake.

Observations of the river channel below the big slide indicate that the river was at flood stage before the slide blocked the canyon. There is much evidence of water flow several feet higher than normal high water. The normal flow of the river would not provide enough water for such a big splash from the slide itself. This conclusion is further substantiated by the numerous fish found high and dry on the flat along the river bank several feet higher than the streambed. Most of the fish observed were the small catfish-like chubs. There were numerous trout and one 18-inch carp. (There is no place in the river below the pool at the toe of the dam where carp would likely be found.)

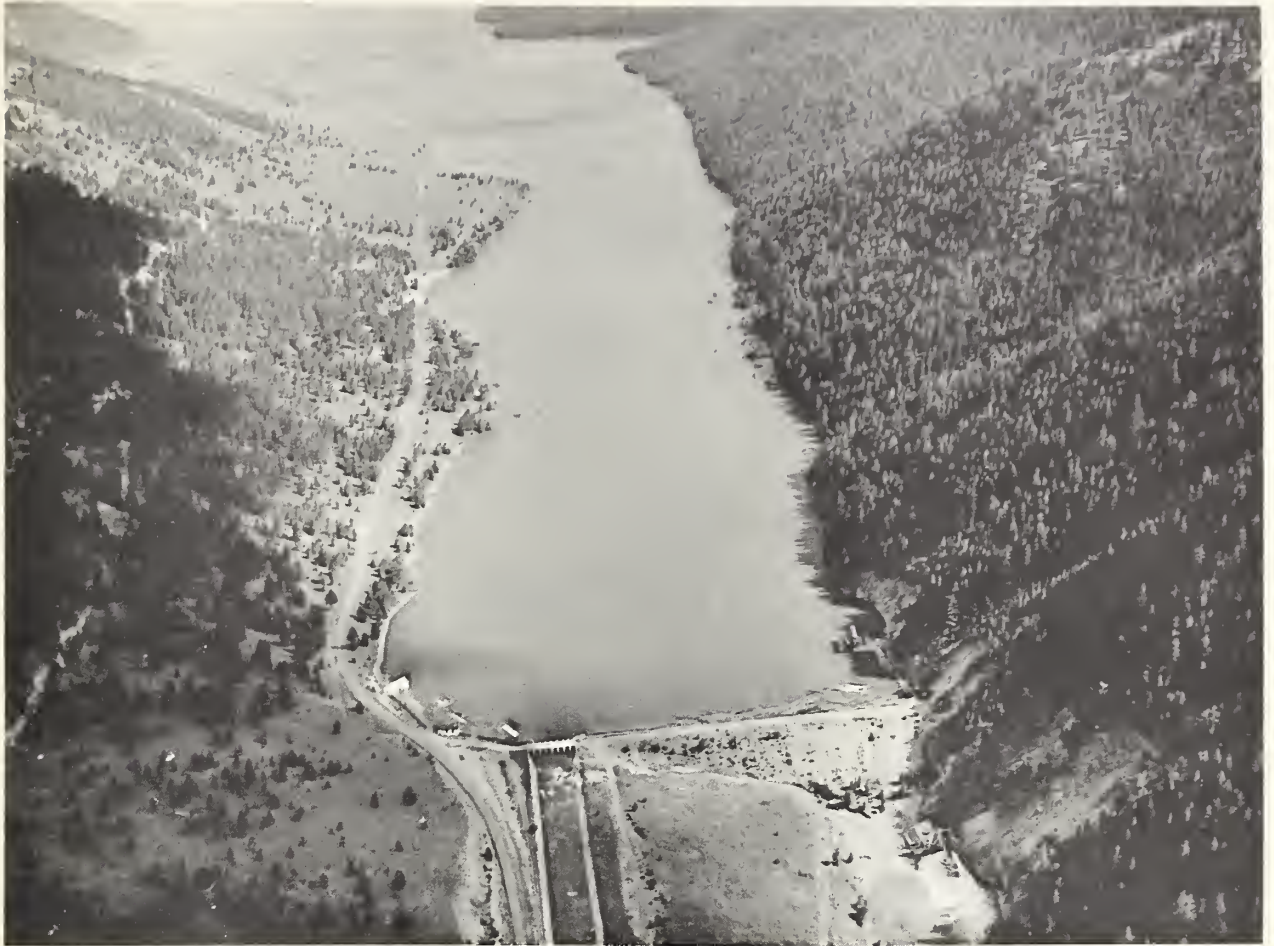
Hebgen Lake Dam

Eyewitness statements relate that the velocity of the tidal wave was such that it caused the water literally to leap over the top of the dam. This is supported by the fact that severe erosion on the face of the dam begins almost exactly along the break line between the roadway on the top of the dam and the sloping

downstream face. The roadway surface across the top of the dam showed little evidence of severe erosion. The water which overflowed the dam damaged the roof of a small power-generating plant and filled the power plant building with rocks and gravel to a depth of 2 to 4 feet.

Note damaged spillway and erosion on face of dam due to tidal wave overflow. Hebgen fault line in left edge of picture.

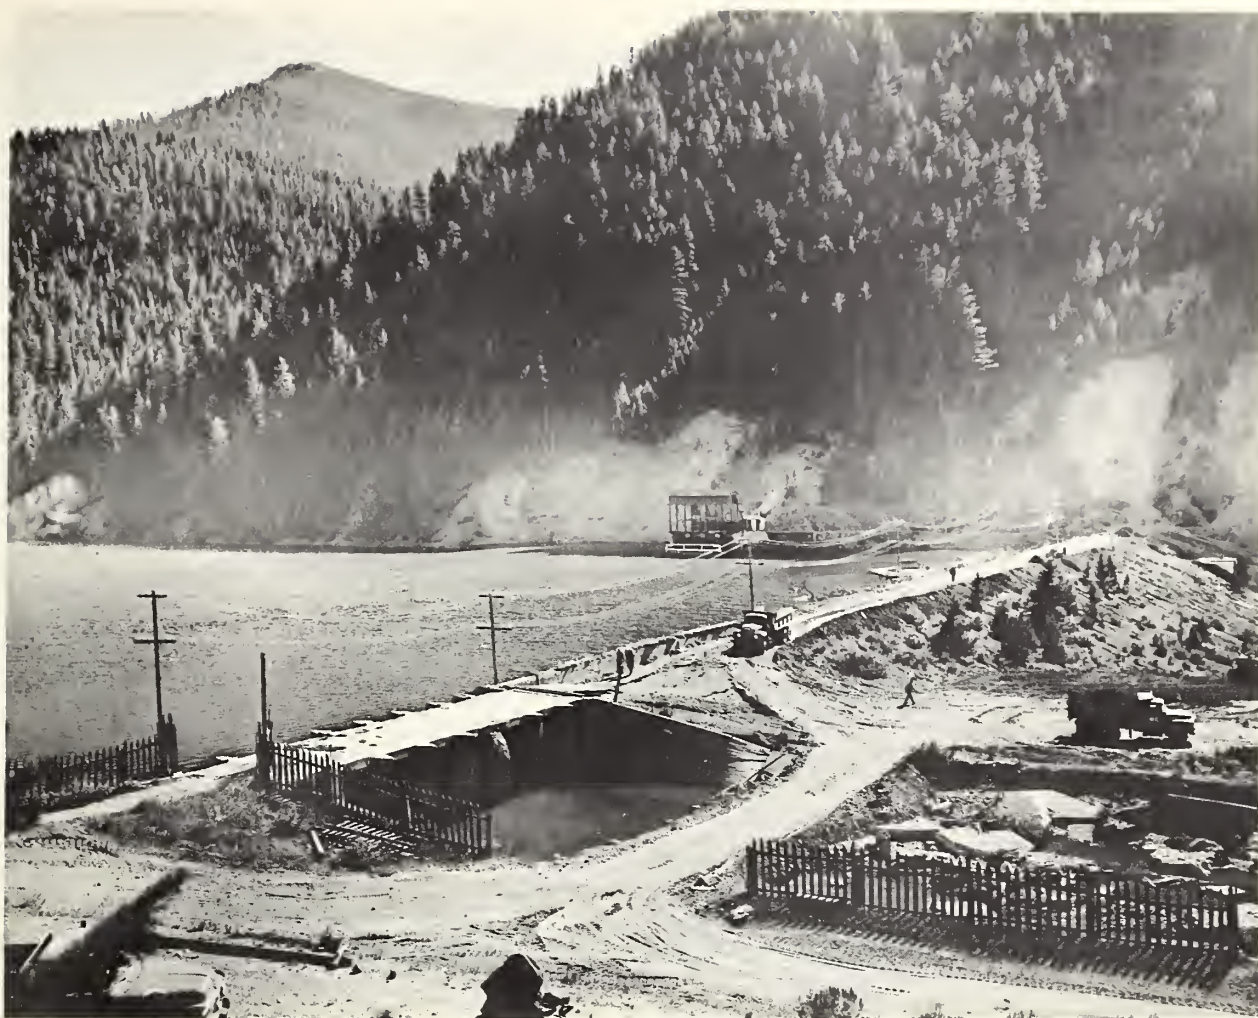
The earthquake caused several fractures in the core wall. Most of these showed no appreciable separation. At the point where the core wall was no longer supported on bedrock, the fracture separated 3 to 4 inches. Level readings by Montana Power Company engineers indicated that the two extreme ends of the core wall are still within .04 foot of being level. The section at the point of greatest fracture, however, is approximately 0.9 foot higher than either end of the core wall.

Hebgen Dam being repaired following earthquake of August 17, 1959. This dam is earth-fill with concrete core. Note how earth settled below concrete core.

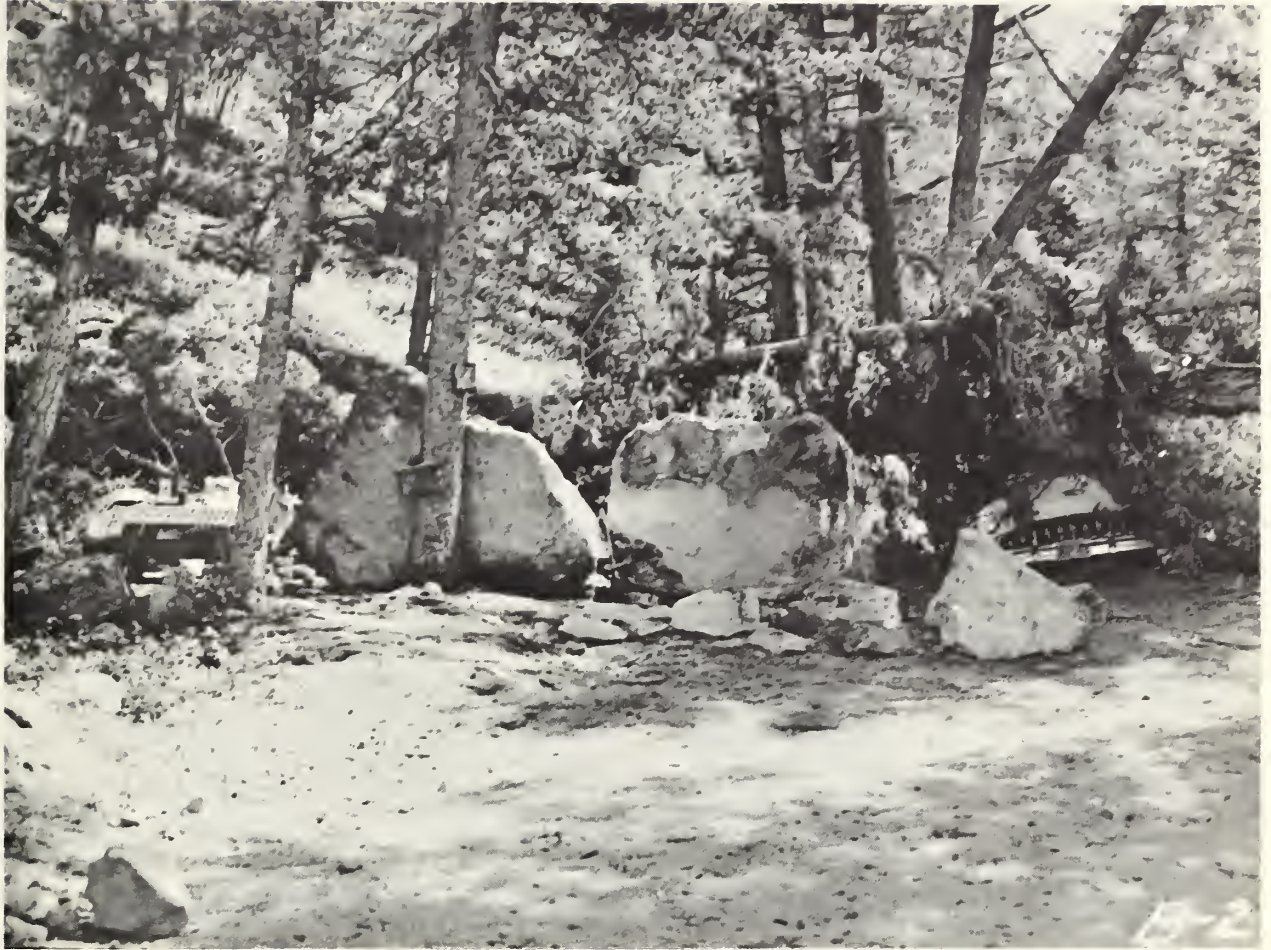
Cliff Lake Campground

Note camp table with food, smashed car, and large boulders on top of tent.
